### Site 329 Rings Island – Ferry Road

Great Marsh Coastal Wetlands Restoration Plan  
Rapid Technical Assessment Site 329

## Rapid Field Assessment

Rings Island - Ferry Road

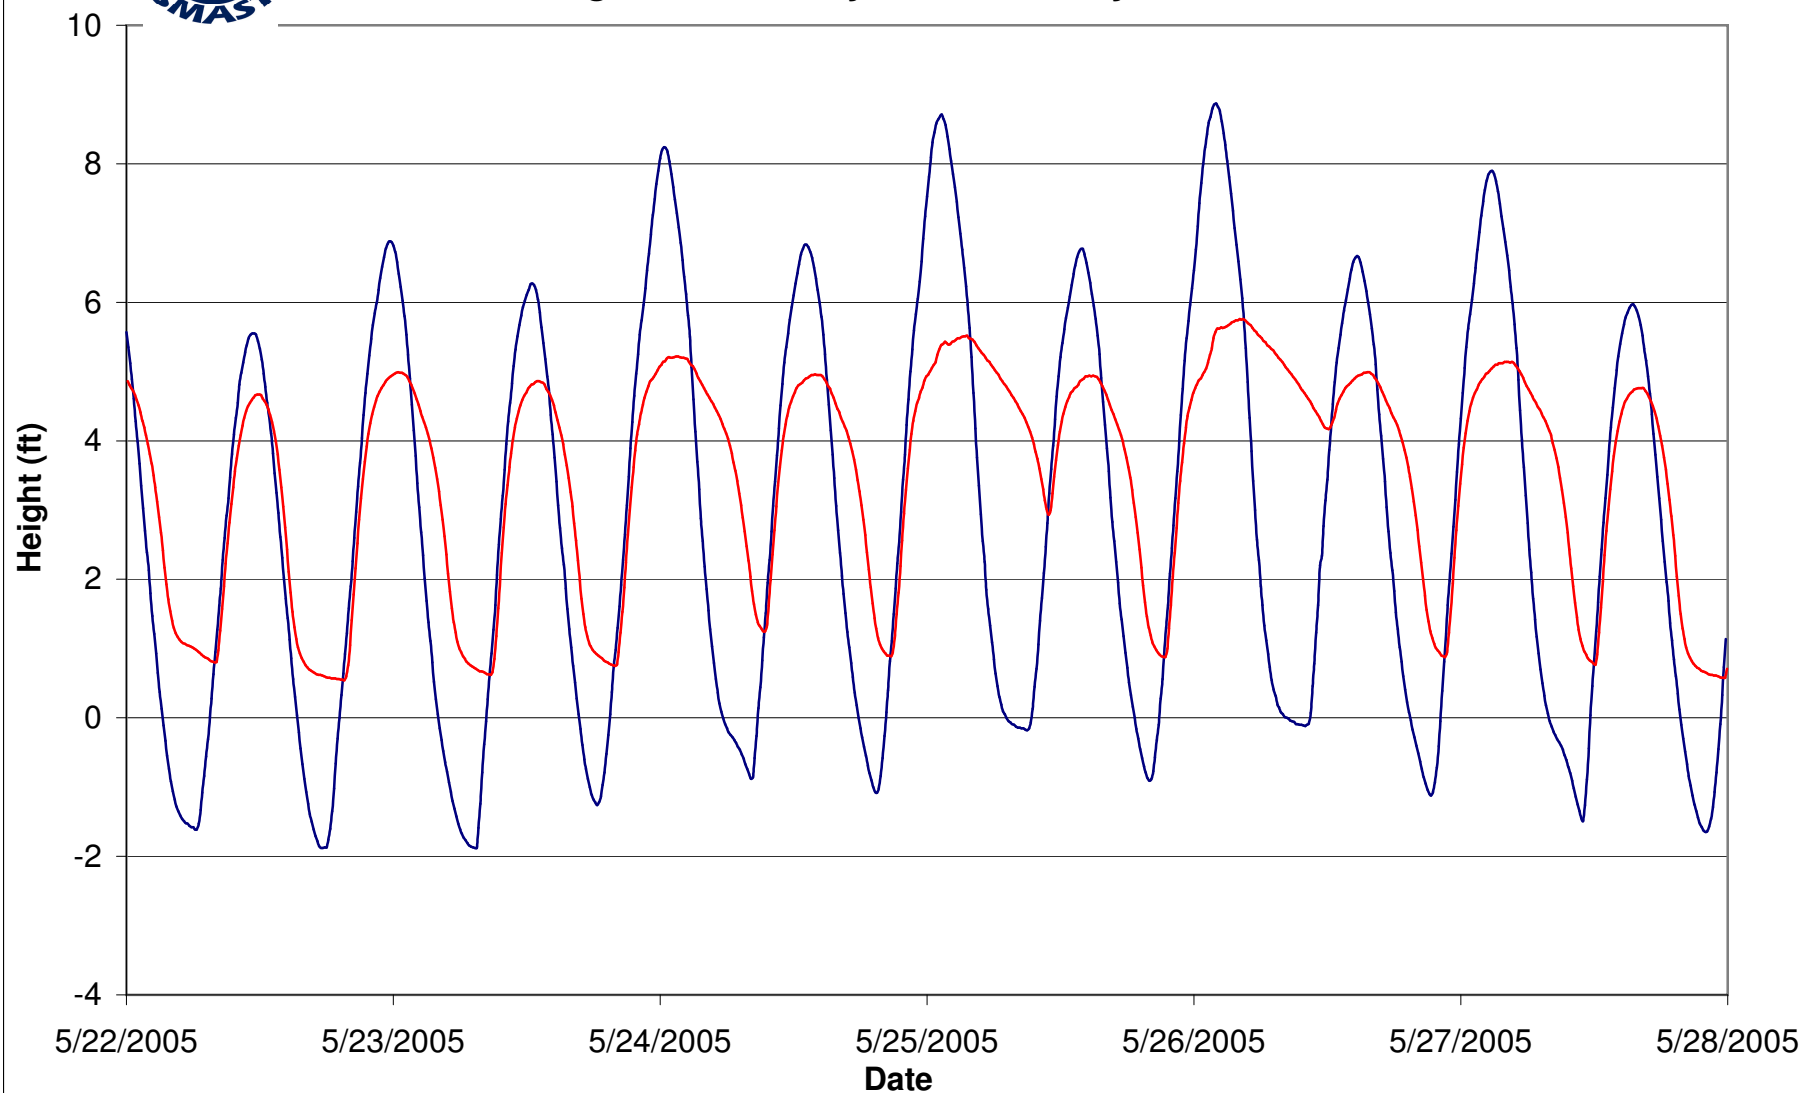
Down Stream  
Up Stream

**Structure conditions:** Tidal flow is conveyed under Ferry Road via a 2.3 ft wide by 3 ft high granite block culvert. The culvert shows some signs of seepage and erosion around the upstream and downstream inverts, but the granite blocks appear to be stable. Riprap protects the upstream and downstream inverts of the culverts from erosion and scour. Stones surrounding the inlet and outlet form a cut stone headwall. There were indications that the pavement around the culvert has been recently repaired. This is typically an indication of settlement or loss of material around the culvert through infiltration. The overall culvert is in fair condition. The creek banks upstream and downstream of the culverts are severely eroded and subsequently have large scour pools. This is most likely a result of high velocities through the culvert and the culvert's poor alignment with the creek.

To increase tidal flow, the existing stone box culvert will have to be replaced with a larger box culvert set lower in the creek channel. The new culvert should also be placed to the north to be better aligned with the creek. This would allow the existing structure to remain in place during construction and avoid the need to construct a temporary bypass. For initial cost estimates we assumed an 8 ft high by 10 ft wide concrete box culvert. A larger structure may be possible pending further modeling and investigations of low-lying abutters. Construction costs associated with replacing the culvert are estimated to be in the range of \$550,000. This effort also assumed some additional work within the upper reaches of the marsh to improve tidal circulation and draining of accumulated fresh water. Additional work within the Rings Island Marsh to improve hydraulic connections to the adjacent potential restoration site is discussed under Site 328.
